FINAL Five-Year Review Report

**Fourth Five-Year Review Report
for
Standard Steel & Metals Salvage Yard (USDOT)**

Anchorage, Alaska

April 2018

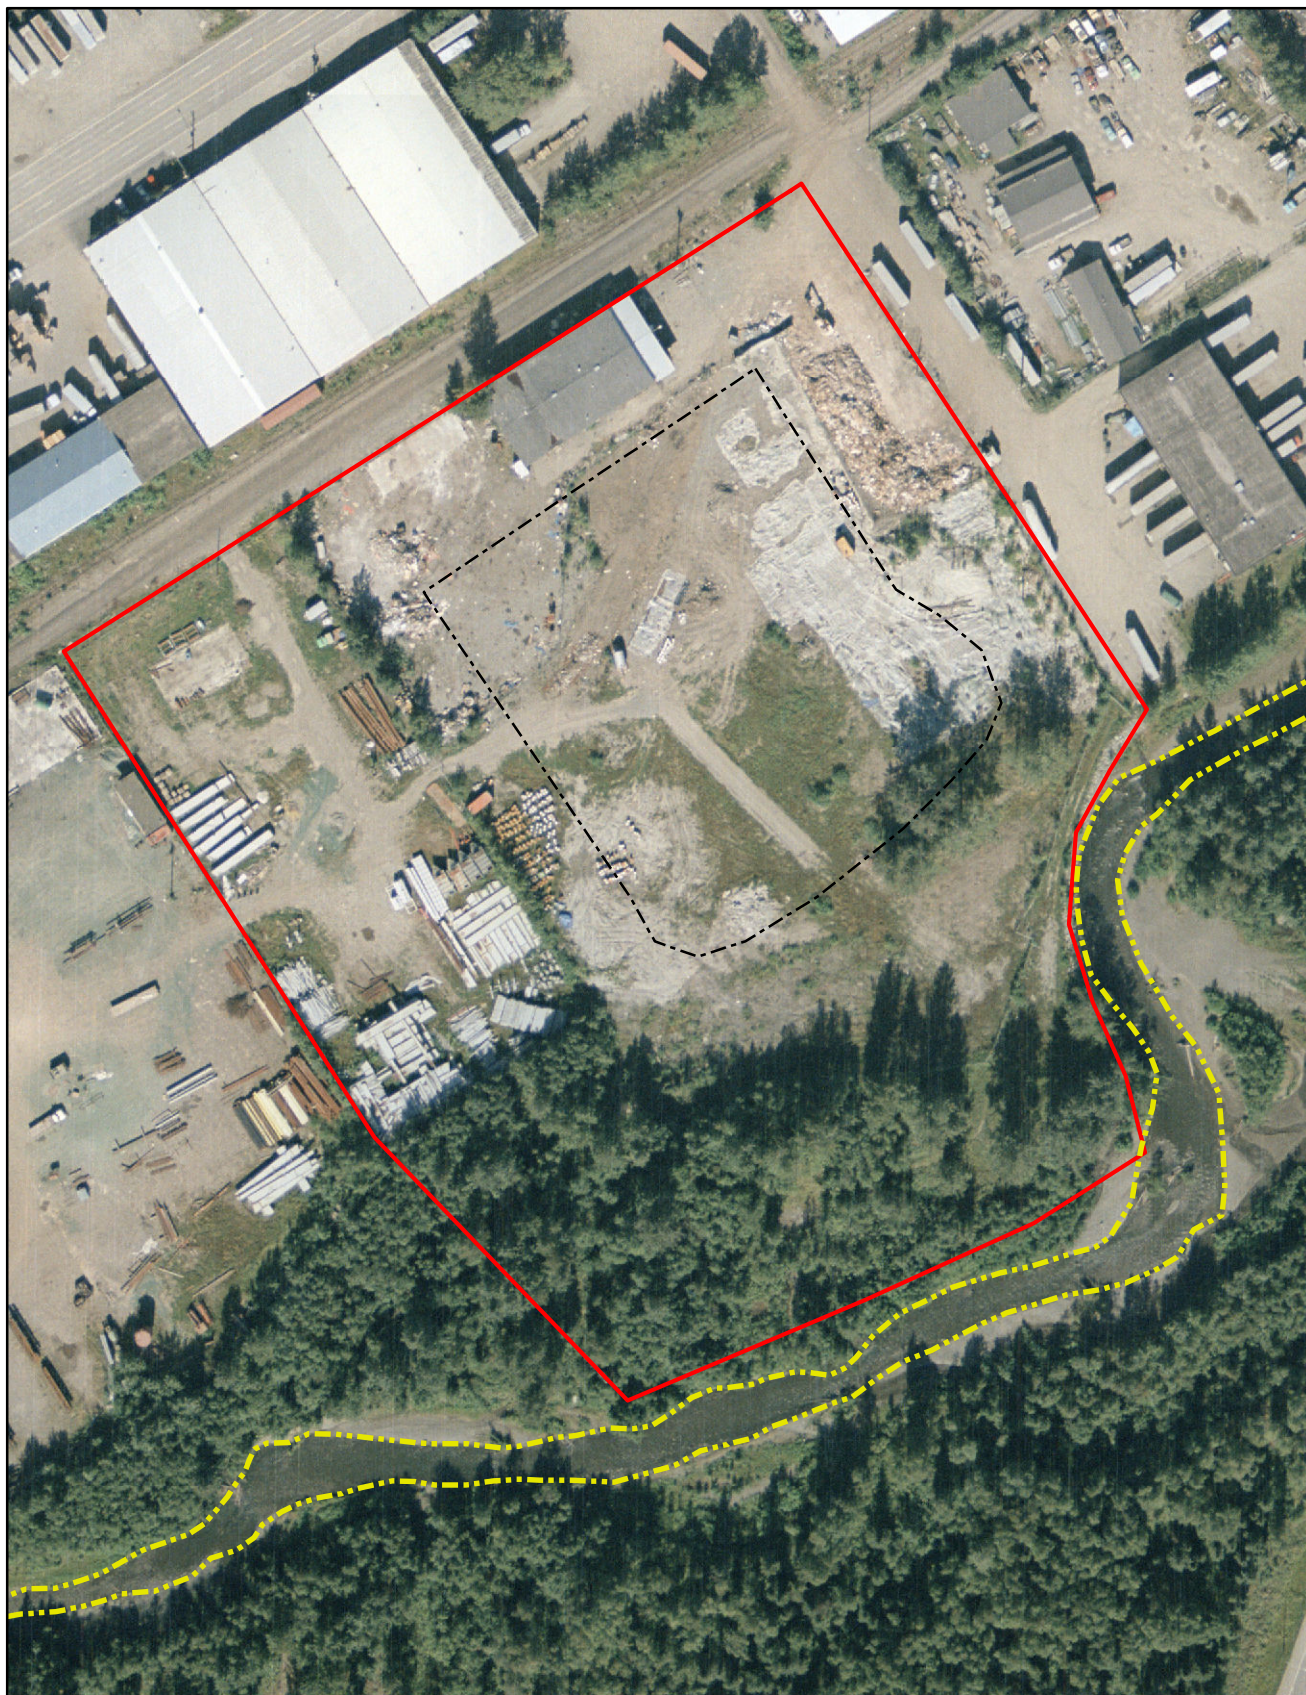
Ship Creek continues to erode its banks. A portion of the north bank nearest to the consolidation cell which eroded during the 2012 flood continues to migrate towards the landfill cap. Aerial photographs from August 1995 (Figure 5), October 2012 (Figure 6), and September 2017 (Figure 7) were reviewed to determine if significant stream channel erosion had caused the stream to migrate towards the landfill consolidation cell since it was constructed. The 1995 aerial photograph depicts the stream channel prior to the construction of the consolidation cell; the 2012 aerial shows the impact from the last major flood event; the 2017 aerial is the most current photograph of the stream channel. Although the stream channel morphology has naturally changed since 1995, a comparison of the aerial photographs (Figure 8) appears to demonstrate the stream channel has only slightly migrated towards the landfill consolidation cell.

Recommendation: Continued monitoring of the Ship Creek streambank should be conducted during the next Five Year Review, including visual inspection and aerial photo comparisons. The consolidation cell was designed to allow for normal geologic processes should the entire channel of Ship Creek migrate northwards. The consolidation cell's erosion control wall construction extends well below the bottom elevation of Ship Creek and is

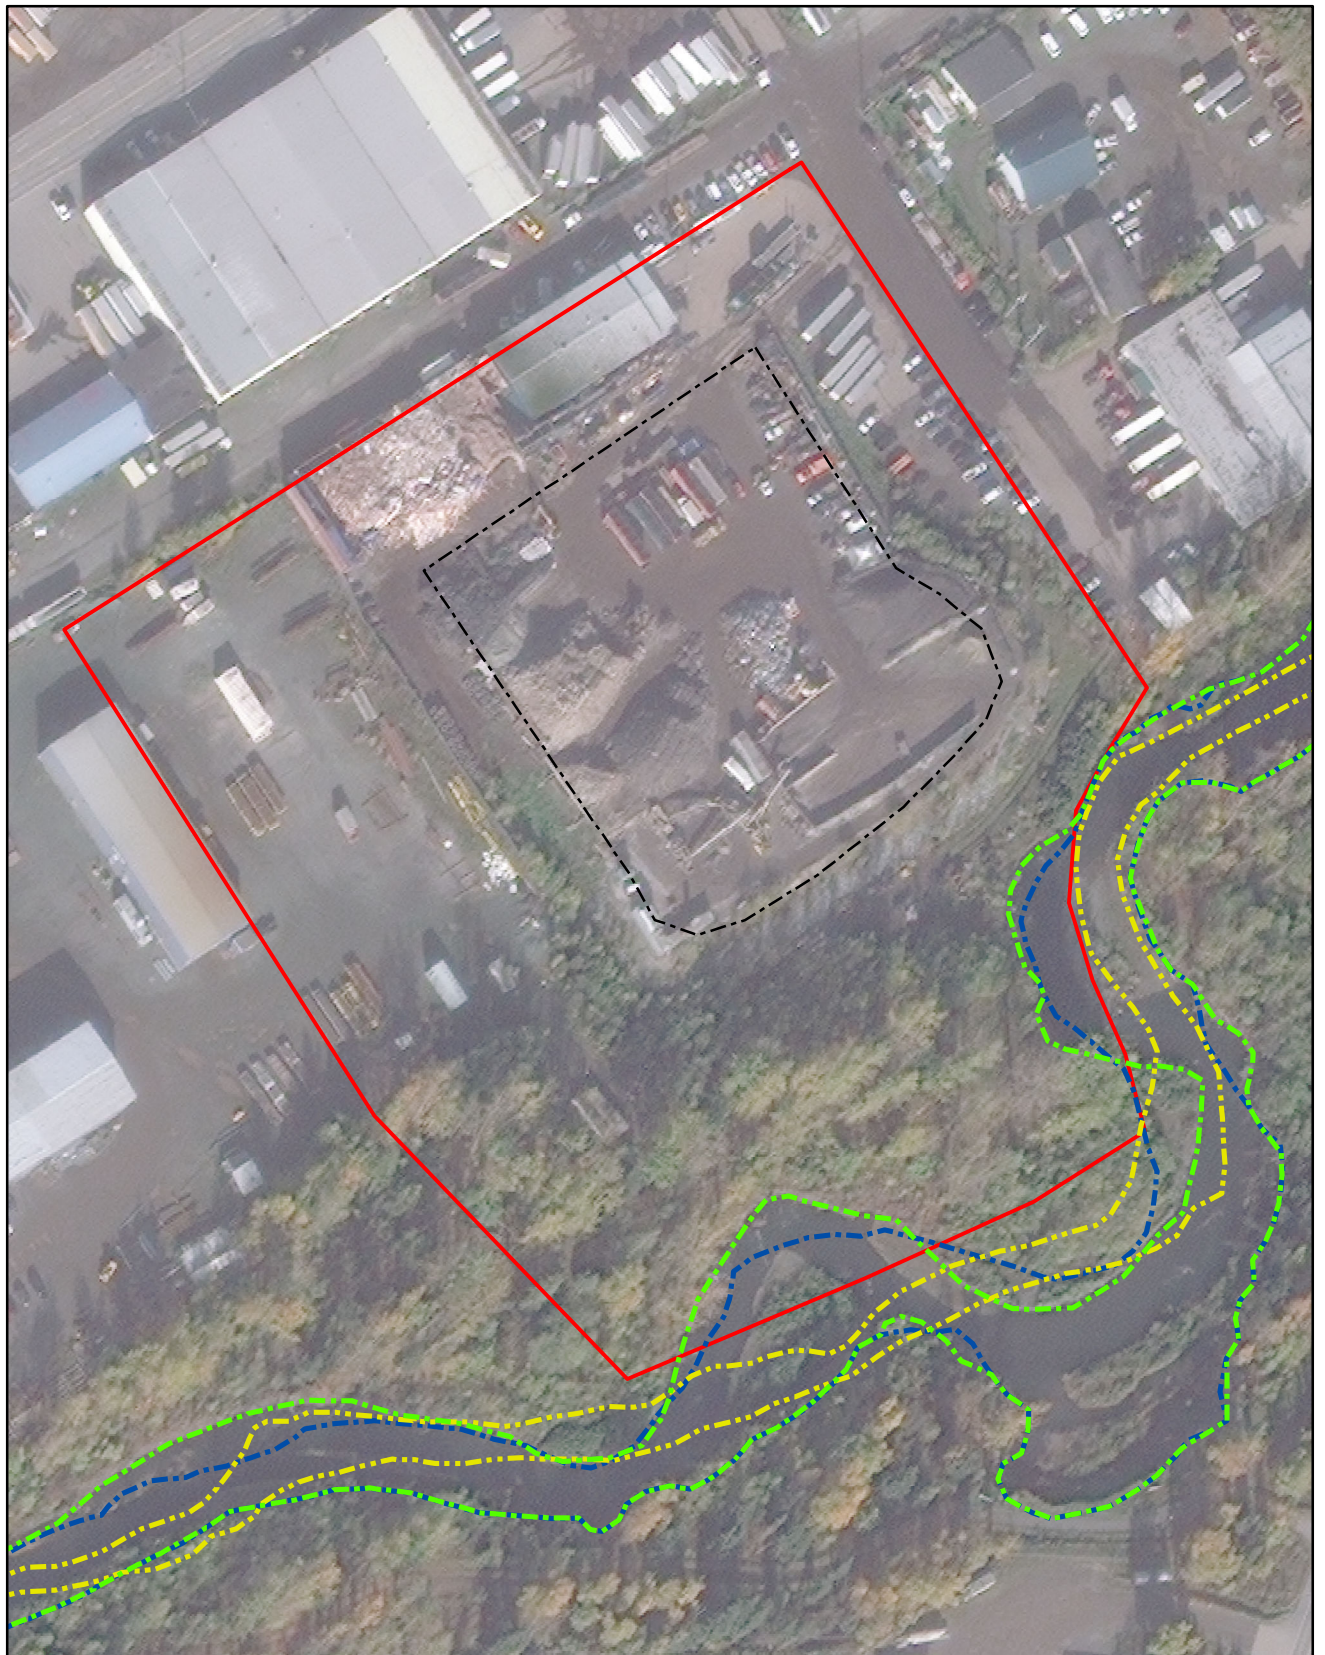
The natural channel of Ship Creek had also visibly changed since the previous five year review. Key components of the implemented remedy include maintenance and repair of erosion control structures on bank of Ship Creek, including placement of artificial logs, large boulders, and native vegetation. Several of the large boulders previously located on the floodplain immediately south of the consolidation cell were visible in the active stream channel, which has continued to erode towards the north and undercut the stream bank.
